## VEHICLE INSPECTION REPORT

**SF16CLP**

### Vauxhall Movano 2.3 CDTi BiTurbo ecoFLEX H1 Crew Cab Tipper 136ps

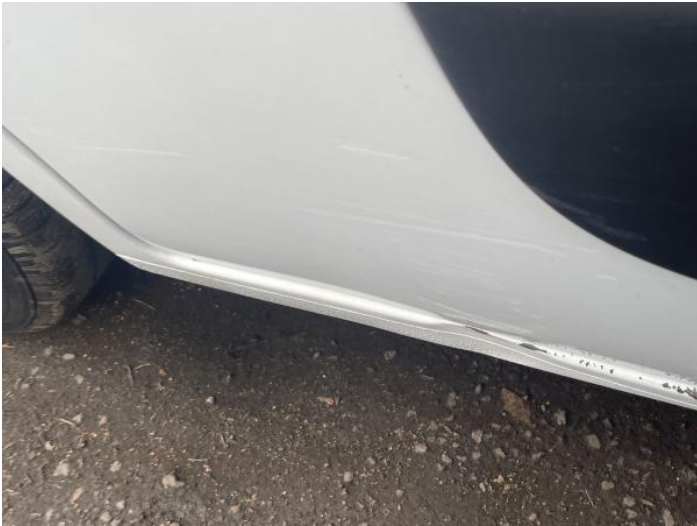
9: Door nsf  
Dented  
With Paint Damage

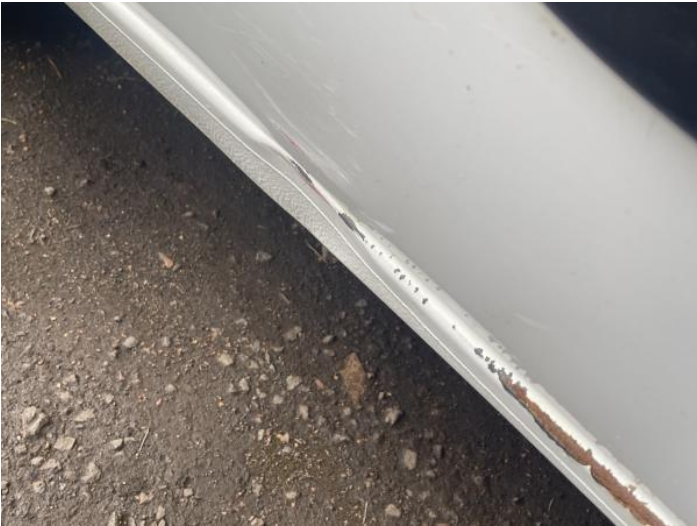
10: Sill ns  
Dented  
With Paint Damage

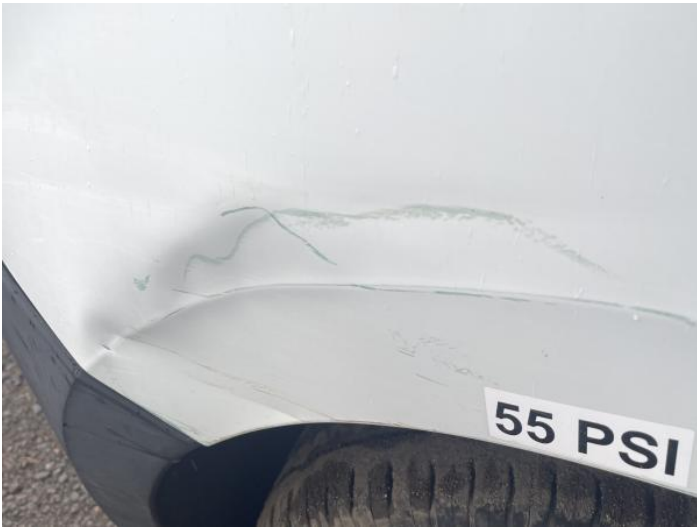
11: Wing nsf  
Dented  
With Paint Damage
